WATERTOWN ARSENAL
LABORATORY

MEMORANDUM REPORT

Metallurgical Examination of Defective and Satisfactory

Helmets and Helmet Steel Stock Furnished by the

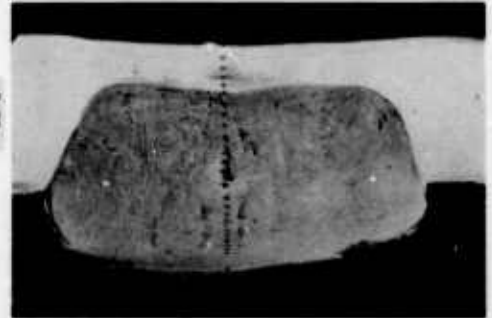
Unetched -A- X25
Helmet C4, McCord Lot 549B, Sharon
Heat 72198. Severe fusion zone
cracking in the Hadfield Steel.
Very poor weld.

Unetched -B- X25
Helmet C1, McCord Lot 533A, Carnegie
Heat 186917. Weld porosity and
fusion zone cracking.
Unsatisfactory spot weld.

Nital -C- X100
Helmet C1. Area shown in -B-.
Severe cracking at boundary of base
metal and zone molten during spot
welding. Dendritic structure in
molten region.
